TECHNICAL REPORT AFATL-TR-74-70

# PLASTIC FRANGIBLE PROJECTILE GUN FUNCTION TEST

Stephen J. Bilsbury, Major, USAF  
GUNS AND ROCKETS BRANCH  
GUNS AND ROCKETS DIVISION

MARCH 1974

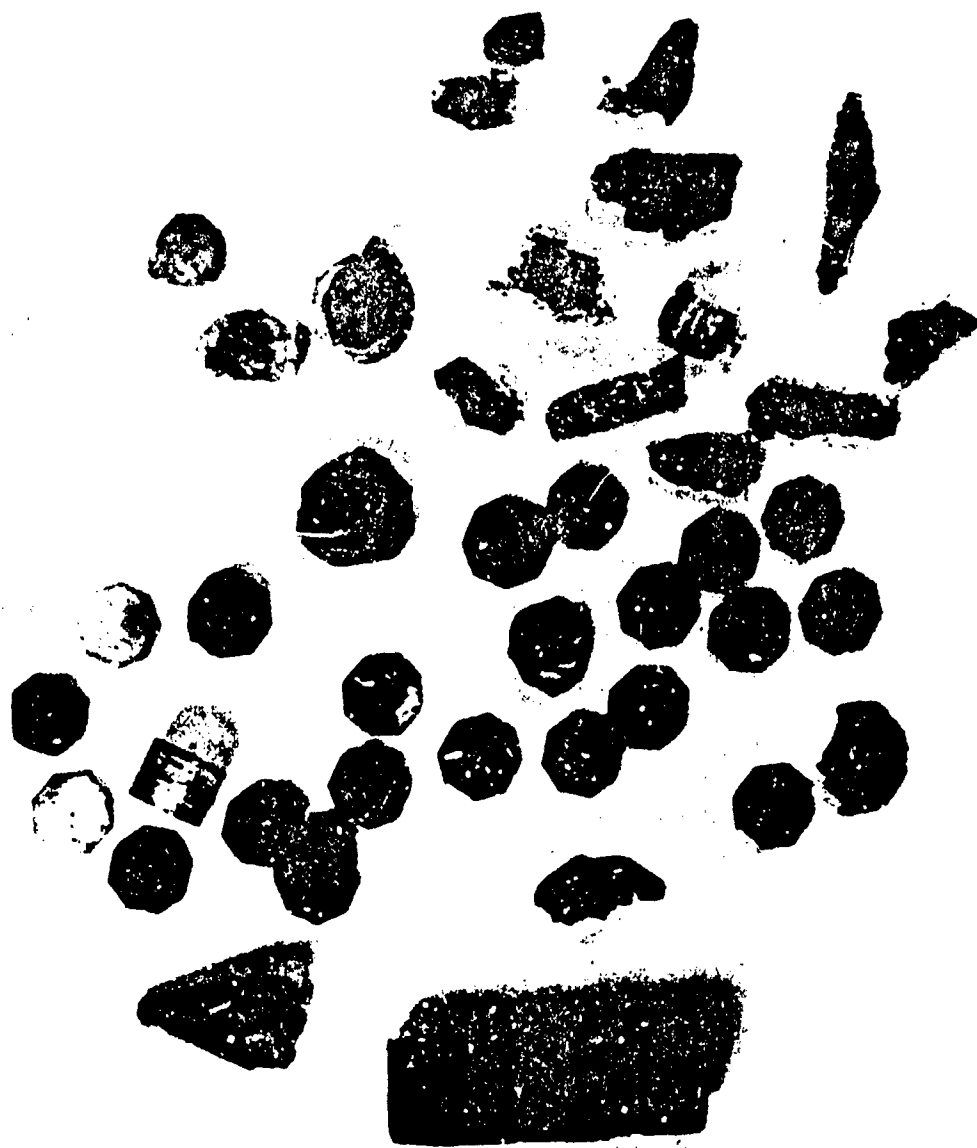
Figure 4. Plastic Frangible Projectiles After Impact On Soft Sand At 45° Angle Obliquity

3. There was no evidence of any intact projectiles in the target backstop, which was soft sand at a 45° angle with the horizontal (See Figure 4).
4. Fragments of Projectiles picked up at the target backstop provided the following observations:

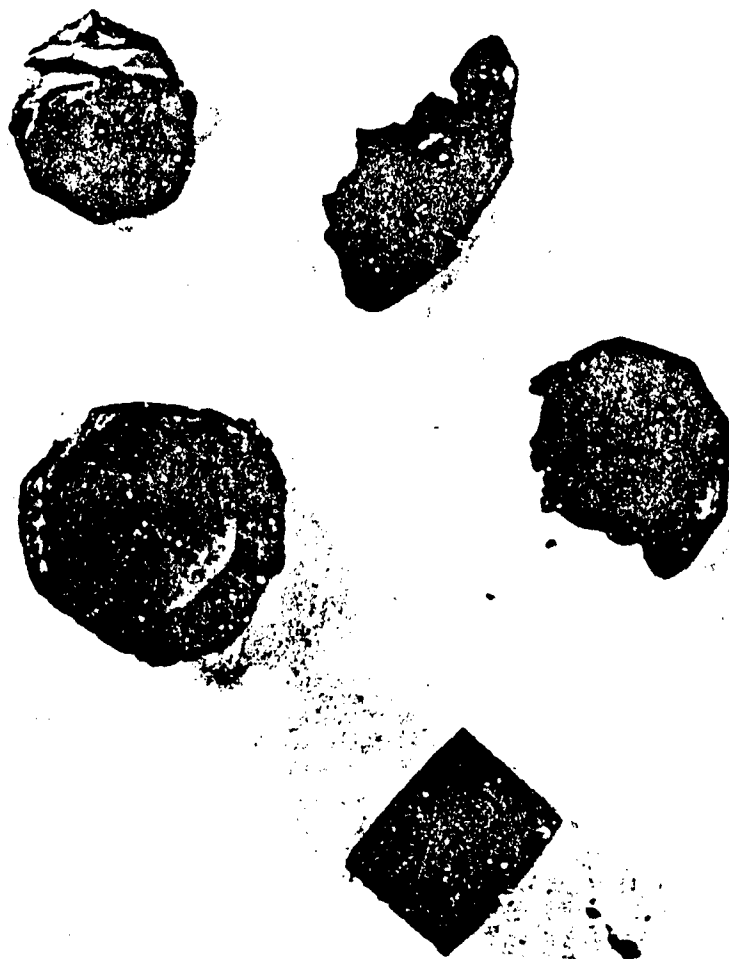
- a. It was noted that in several cases, groups of washers stayed together; however, they were not welded together and came apart easily in the hand (See Figure 10).

**Figure 10. Metal Platelets of Plastic Frangible Projectiles  
Obtained at Target Backstop**

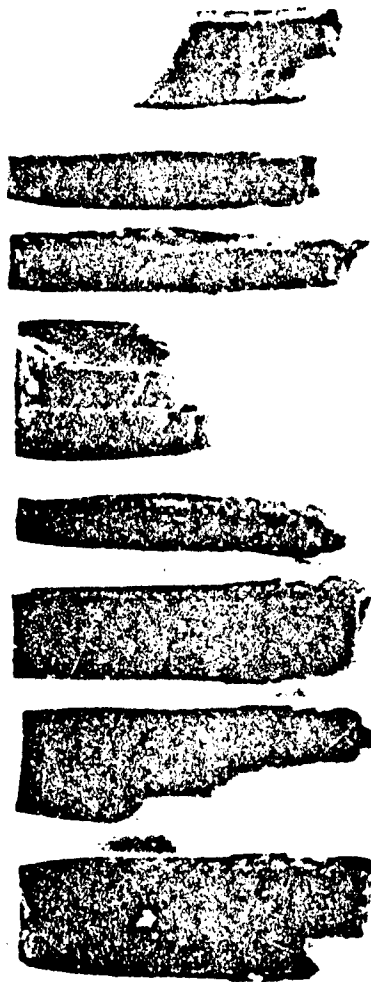
- b. The plastic is being cold-formed to the extent that it is being squeezed between the washers, which are under compression due to acceleration. This occurs from the leading edge of the rotating band to the projectile base. (See Figures 11 and 12).

- d. There is little evidence of a good bond between the projectile tip and the body, i.e., those fragments observed indicated an almost smooth, as molded, surface, with no indication that interfacial melting had taken place. (See Figures 11 and 13).

Figure 11. Plastic Fragments of Plastic Frangible Projectiles  
Obtained at Target Backstop (Reverse)

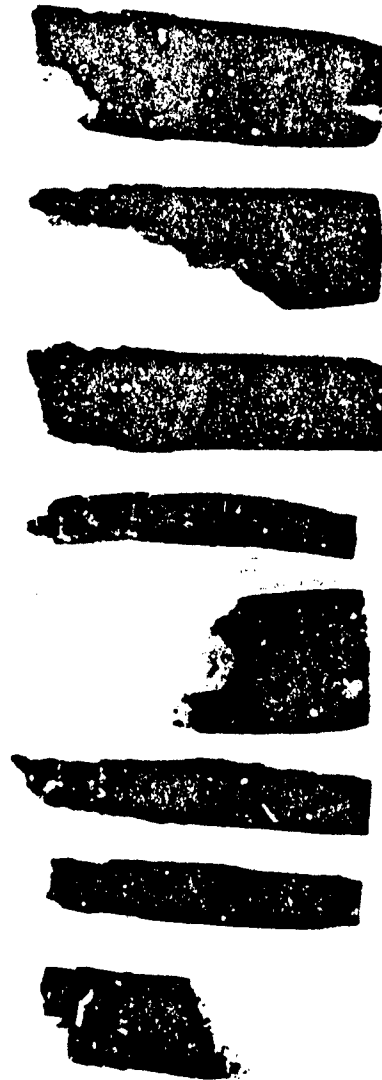
- c. One almost intact plastic projectile body showed that gun gas is apparently escaping around the lands and grooves, thus darkening the projectile body forward of the rotating band (See Figures 12 and 13).

Figure 12. Plastic Fragments of Plastic Frangible Projectiles  
Obtained at Target Backstop (Obverse)

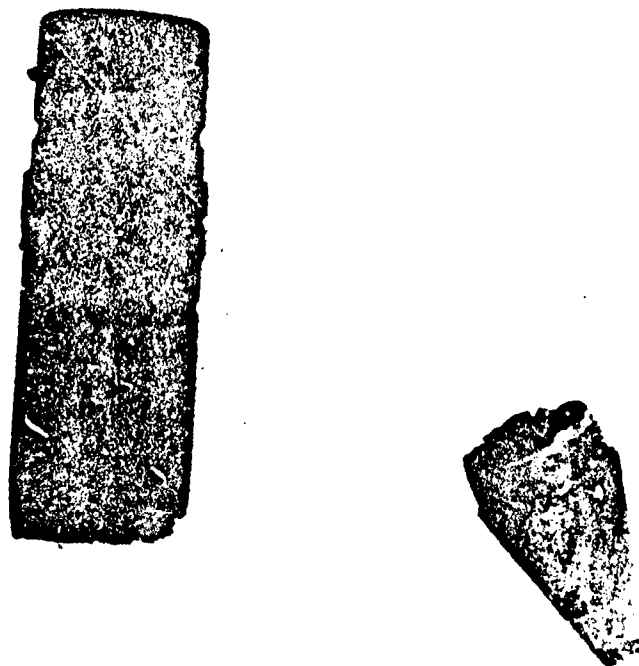
Figure 13. Plastic Sections

1. Should the current design be continued, a positive method should be devised to assure the integrity of the bond between the tip and projectile body.
2. An improved plastic encapsulation design should be devised.

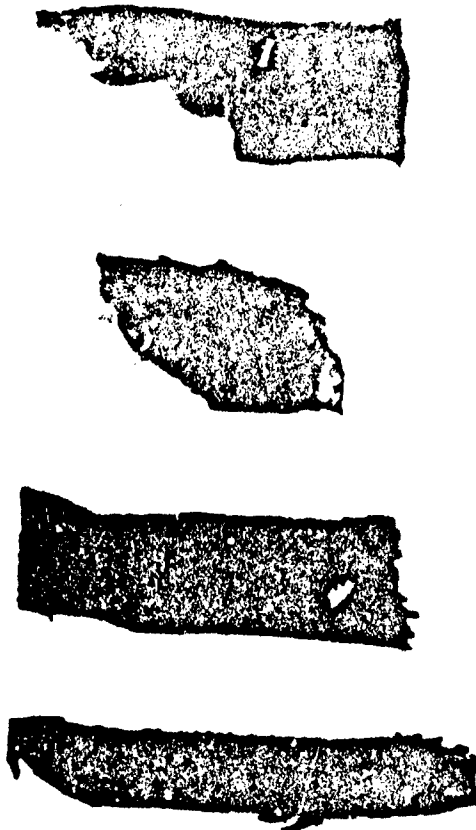
- b. The plastic body is breaking along the sharp edges of the octagonal platelet (independent of engraving by the lands and grooves of the barrel). See Figures 14 and 15).

Figure 15. Plastic Fragments Obtained  
At Gun Muzzle (Obverse)
